ENVIRONMENT AUDIT

STUDY PERIOD (ONE YEAR) 2024 - 2025

Sustainability study **AUDIT REPORT**

Studied for
CMR Engineering Educational Society's
CMR Engineering College
Kandlakoya Village, Medchal Road,
Hyderabad- 501401, Telangana, India

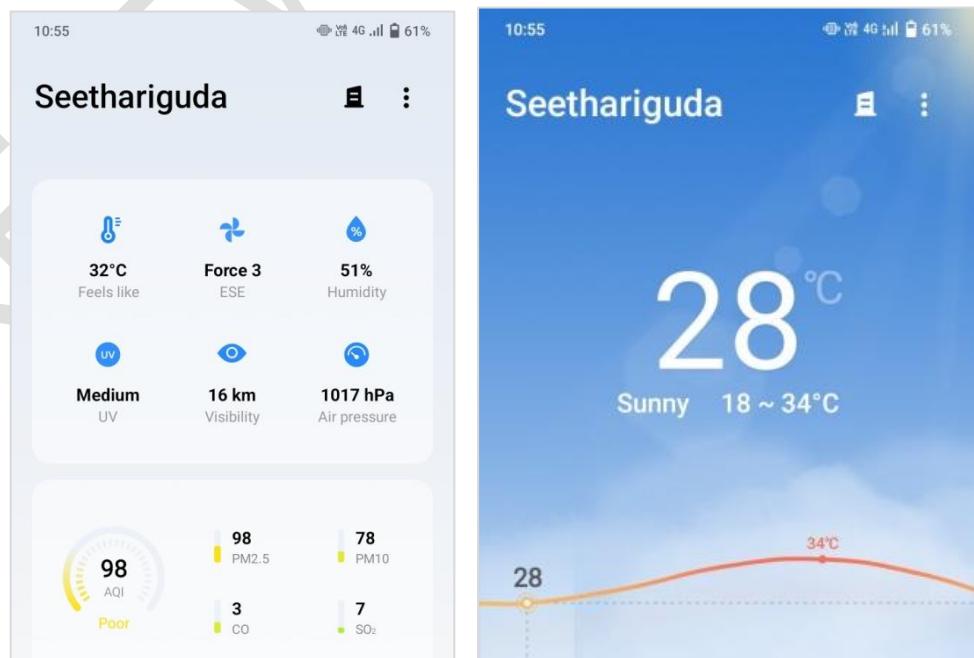
Figure 2: Study at F-Block outdoor area

2. F-Block @ 10:54 (Outdoor)

S. No.	Space	Location	AQI result	AQI category as per IMD	Requires improvement
1.	F-Block	Indoor	90	Satisfactory (51-100)	Yes
2.	F-Block	Outdoor	98	Satisfactory (51-100)	
3.	A-Block server room	Indoor	98	Satisfactory (51-100)	
4.	Transformer area	Outdoor	95	Satisfactory (51-100)	
5.	C-Block	Indoor	95	Satisfactory (51-100)

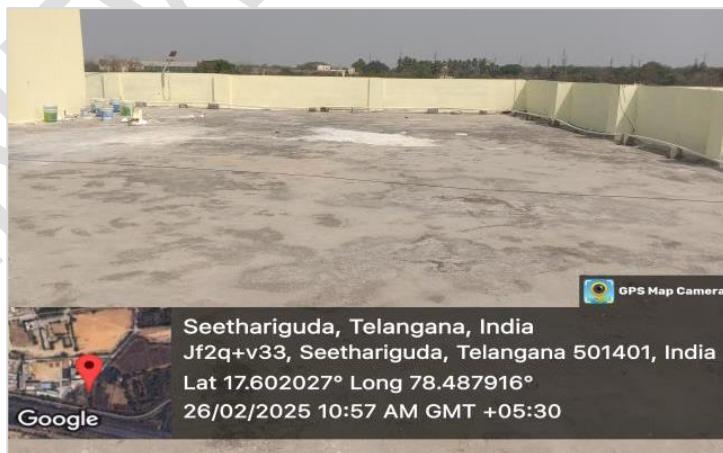
- ⌚ Situated away from the city to some extent.
- ⌚ Very close to oxygen park.
- ⌚ Light colored facades

Plate 4: Certain spaces have cool rooftops

The rooftop has been upgraded with cool-top material to reduce heat absorption and create an energy-efficient environment.

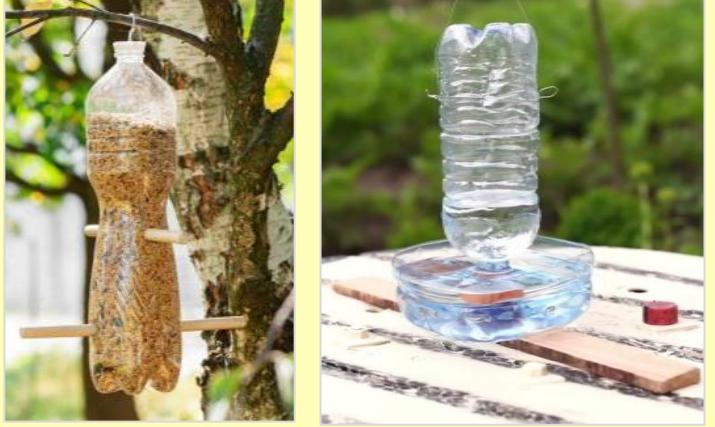
<p>Food and water feeder</p> <p>Waste plastic bottles can be recycled & used as a student activity</p>

2.	Biodiversity aspect <u>Aspect area:</u> Water and food feeders	At appropriate locations there can be provisions for drinking water and some grains for birds as they visit the site much frequently.

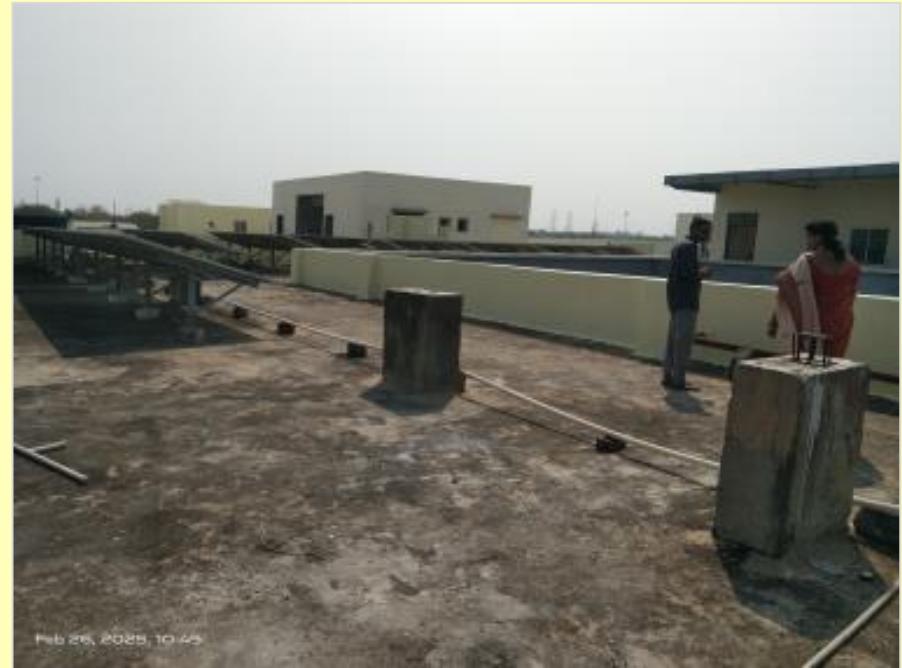
Plate 5: Cool roof comparative analysis (For reference purpose only)

Current status

Proposed status

4.	Carbon footprint aspect <u>Aspect area:</u> Cool rooftop	<ul style="list-style-type: none"> ➲ Keep terrace areas free of any kind of storage materials ➲ Terrace rooftops can be painted with Cooltop (Reflective material) to reflect the harsh sun rays and reduce the heat absorption in the top most floor and surrounding areas of the building. ➲ Introduce signboards about 'No students are allowed to

- ➲ Undertake feasibility study of before - after temperature reading.
