GREEN AUDIT

STUDY PERIOD (ONE YEAR) 2024 - 2025

AUDIT REPORT

CMR Engineering College

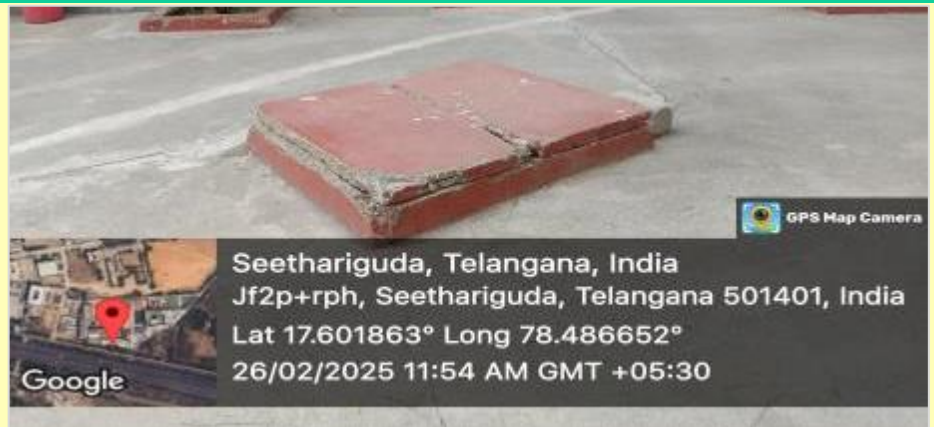
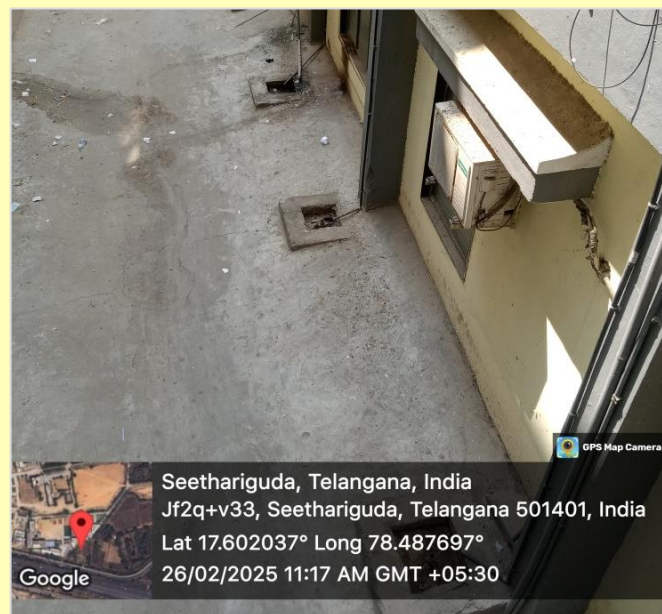
4. Water aspect
Aspect area:
Information display

<p>Every water tank in ground and terrace/ external pit/ water cooler should be painted with information as follows:</p> <ul style="list-style-type: none"> ➤ Nos. ➤ Capacity in cu. Litres or litres ➤ Usage – Primary (Drinking); Tertiary (Rain water) and Secondary (Cleaning, washing, flushing, watering etc.) ➤ Last cleaning maintenance date and by whom ➤ Name and logo of the Institute <p>Paint the pits and use colour coding as follows:</p> <ul style="list-style-type: none"> ➤ Red – Fire ➤ Cobalt blue – Rain Water harvesting ➤ Sky blue - Drinking water ➤ Grey – Electrical ➤ Brown – Sewage/ waste water
